# Biomechanical Analysis of the Pectoralis Major Tendon and Comparison of Techniques for Tendo-osseous Repair

**Study Design:** Controlled laboratory study.

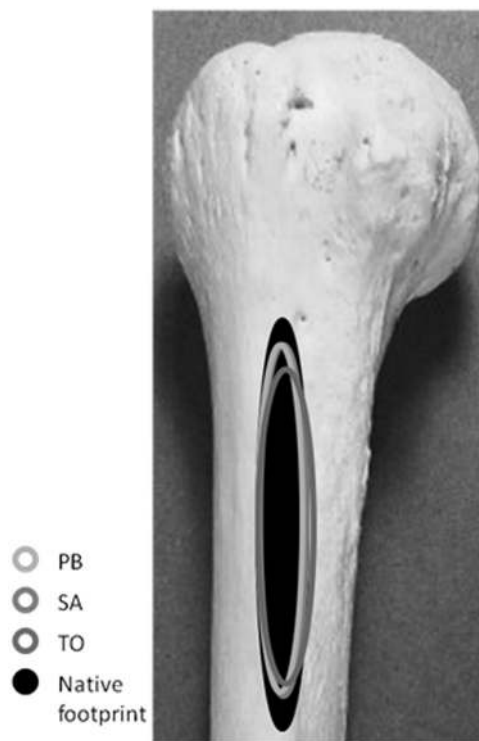
**Figure 3.** Native footprint and the restored footprint after each repair. PB, Pec Button; SA, suture anchor; TO, transosseous.

There was no significant difference ( $P > .05$ ) among groups with regard to age, bone density, sex, or shoulder side (Table 1). Table 2 summarizes the footprint length and midportion width of the specimens before and after repair as well as the percentage change of footprint dimension. All repair groups demonstrated adequate footprint restoration with no significant differences detected between the repair types (Figure 3). The restored footprint length of

all 3 repair groups was significantly shorter than the intact footprint; however, the restored footprint thickness of all 3 repair groups was not significantly different from the intact footprint.

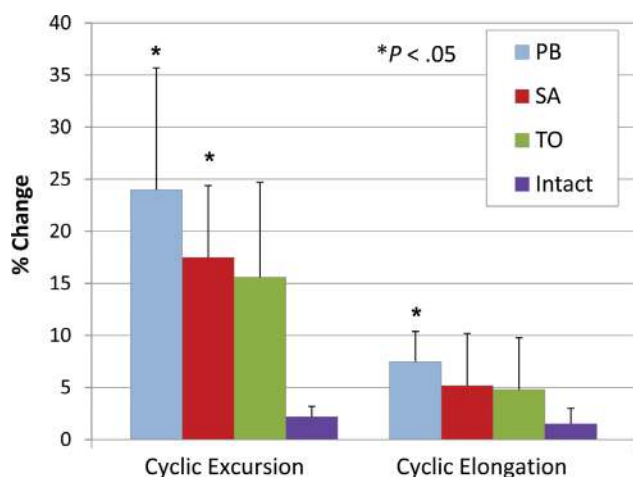
Figure 4. Cyclic excursion and cyclic elongation of the repair groups and intact specimens. \*Significantly different from the intact group. PB, Pec Button; SA, suture anchor; TO, transosseous.

showed a significantly higher initial excursion than the intact group. The Pec Button group demonstrated a significantly higher cyclic elongation than the intact group (Figure 4). The intact group exhibited a significantly higher secant stiffness of both the first 5 and last 5 cycles compared with the 3 repair groups (Table 3). There were no significant biomechanical differences among the repair groups.
